# Revision Guide for AMD Athlon™ 64 and AMD Opteron™ Processors

Publication # <b>25759</b>	Revision: <b>3.43</b>
Issue Date: <b>April 2005</b>

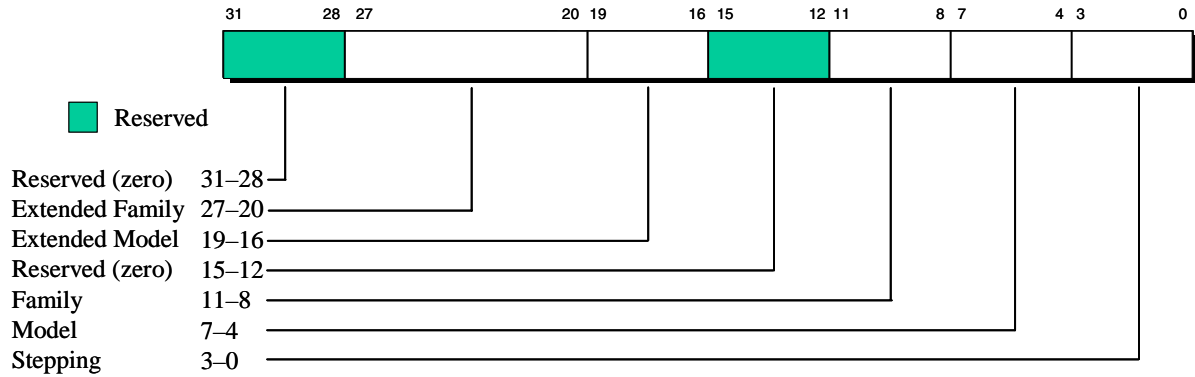
Figure 1 shows the format of the value returned in EAX by CPUID Function 1.

**Figure 1. Format of CPUID Value Returned by Function 1**
